**International Forestry**  
**CONSULTANTS, INC.**

**TREE PLAN FOR WOODY SHORT PLAT**  
**12420 NE 70<sup>TH</sup> COURT**  
**KIRKLAND, WA**

**PARCEL #1241500022**

**JUNE 1, 2007**

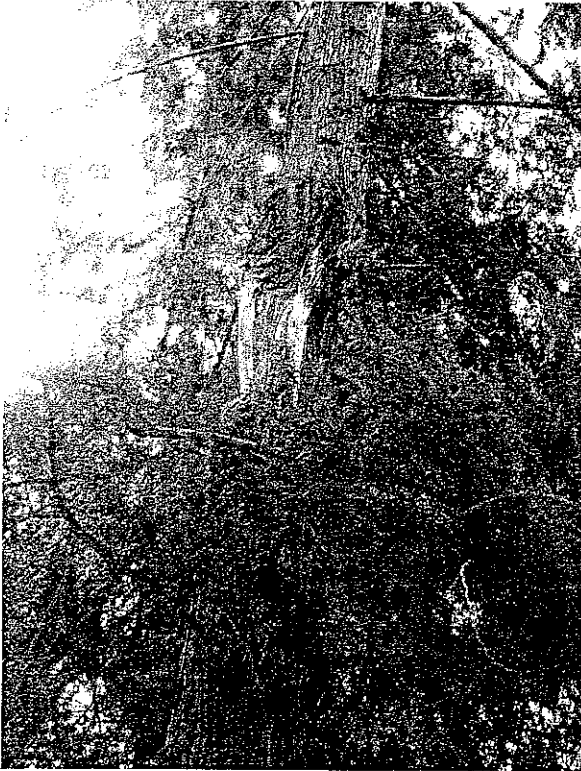
Tree #3 suffered a major failure during the December 14<sup>th</sup> windstorm. This involved the loss of a codominant (equal diameter) stem at approximately 25' above ground. This failure has compromised the structural stability of the remaining stem. See photo. This tree presently represents a serious hazard to the existing house on lot 2.

Tree #3 is a serious hazard and should be removed. The failure of the codominant stem removed more than half of the circumference of the tree at the attachment. The failure pattern cannot be predicted; the top could fall in any direction. This failure represents a serious defect, which has compromised longevity.

Codominant stem failure of Tree #3

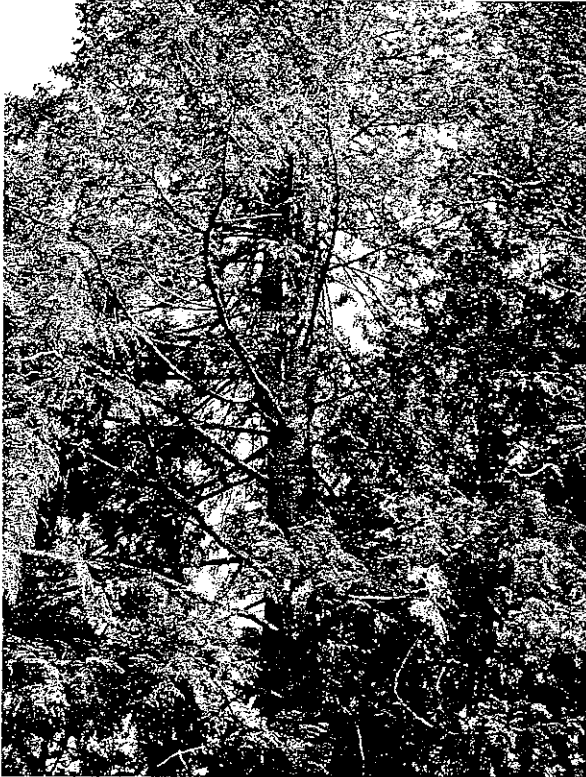
Tree #5 has also developed codominant stems at approximately 40' above ground. These stems appear to be fairly well attached to the main trunk, and not protruding at a narrow angle of attachment. A cavity was observed at the base. A decay column is suspected within the lower trunk. This is not necessarily concerning, as this species naturally develop internal decay as they mature. Minor decay is suspected within the lower trunks of all the mature cedars at this site. Tree #5 is a boundary line tree.

Forked top of Tree #5 – fairly stable

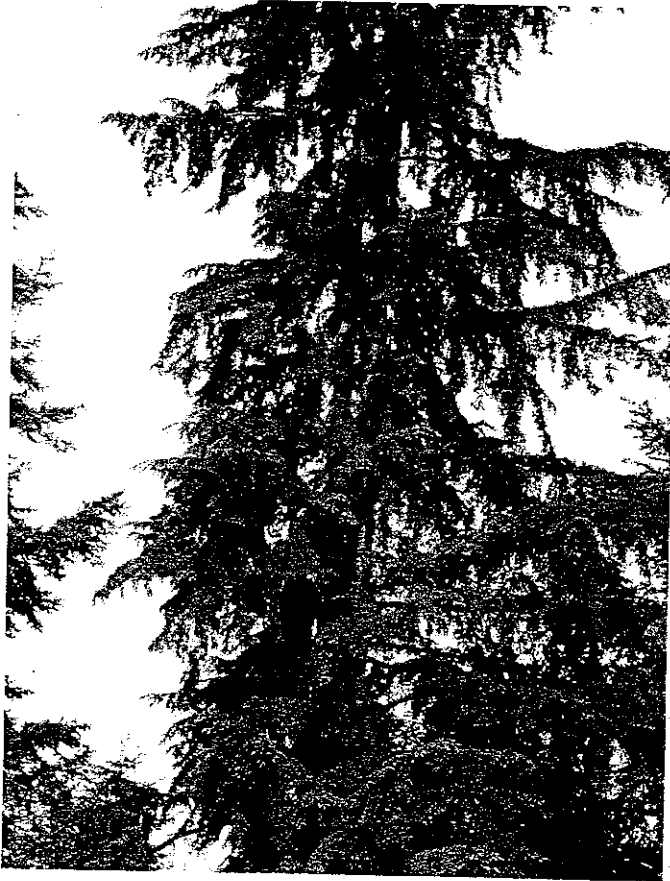
Tree #12 is a mature western hemlock. This tree has developed an unnatural lean to the northwest. Structural stability may have been compromised during the December 14<sup>th</sup> windstorm. The main trunk forks into codominant stems at 36' above ground. These stems appear to protrude from the main trunk via a narrow angle of attachment. The foliage is of fair density and good color. This tree would not be a good candidate for retention through the development of this lot, due to cumulative structural defects and a moderate to high potential for failure.

Trees #12, #15, #20 and #22 are considered nonviable. These are not good candidates for retention through development, due to cumulative structural defects, which represent a high potential for failure. Tree #15 is nonviable due to suitability of species and structural defects.

Forked top of Tree #12

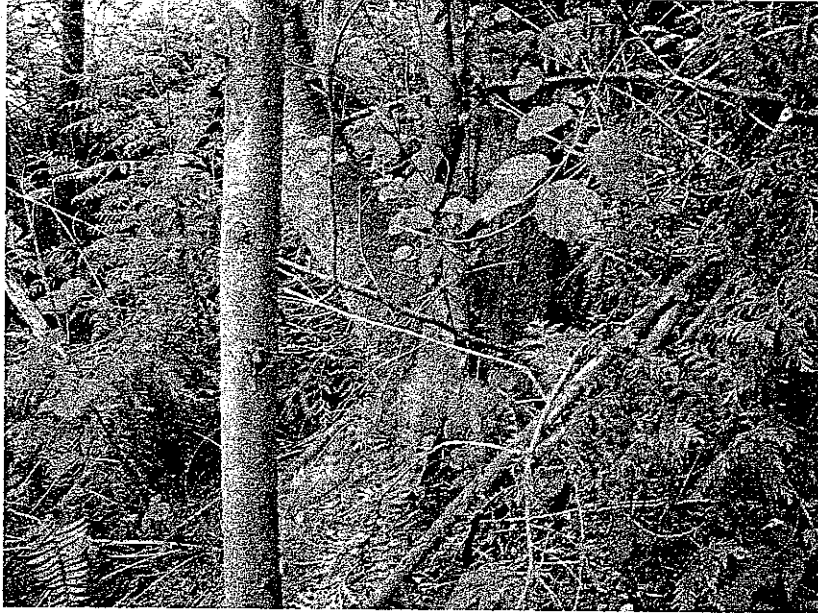
Tree #15 is a semi-mature to mature red alder. The lower trunk forks into 2 stems at 1' above ground. This is not an appropriate tree species to retain near improvements, due to a low tolerance to site alterations. This pioneer species is likely to be problematic in the near future, due to a short life span and usual premature decline in urban areas.

Tree #15 – forked at 1'/poor structure

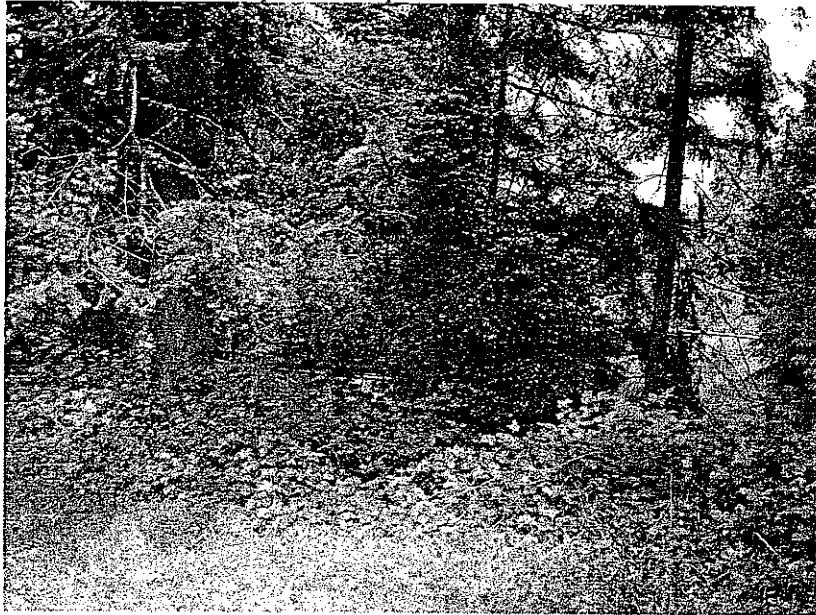
Trees #13, #14, and #16 through #21 are young to semi-mature Douglas-firs. All of these are situated on the slope near the north property line of Lot 1. Most have developed fairly good taper and form. Minor crooks were observed on the boles of most trees. These are considered minor structural defects. The crowns are displaying healthy foliage and good vigor.

Douglas-fir trees on slope of north perimeter

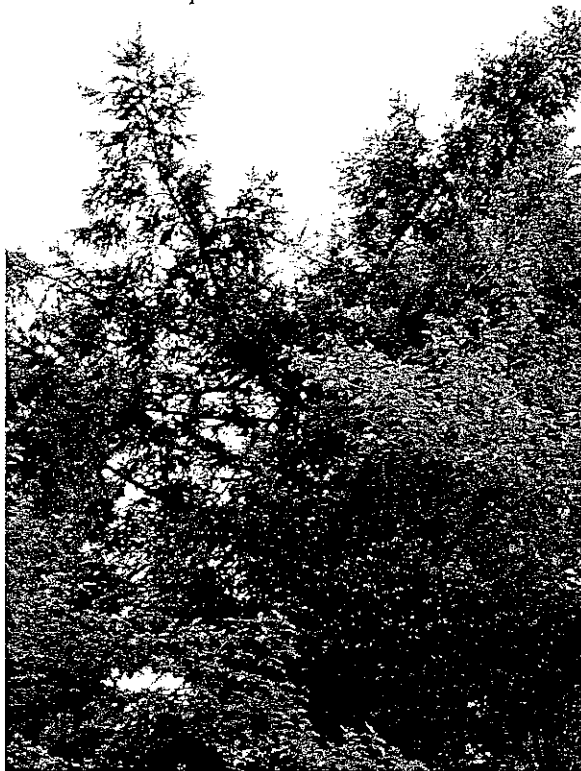
Tree #16 recently lost its top at approximately 40' above ground, probably during the December 14<sup>th</sup> windstorm. It appears the break occurred at a major crook in the stem. A new leader or top is likely to regenerate at the break. Re-growth of new tops is weakly attached and should be monitored periodically. Continued preservation is reasonable at this time.

Recent broken top of Tree #16

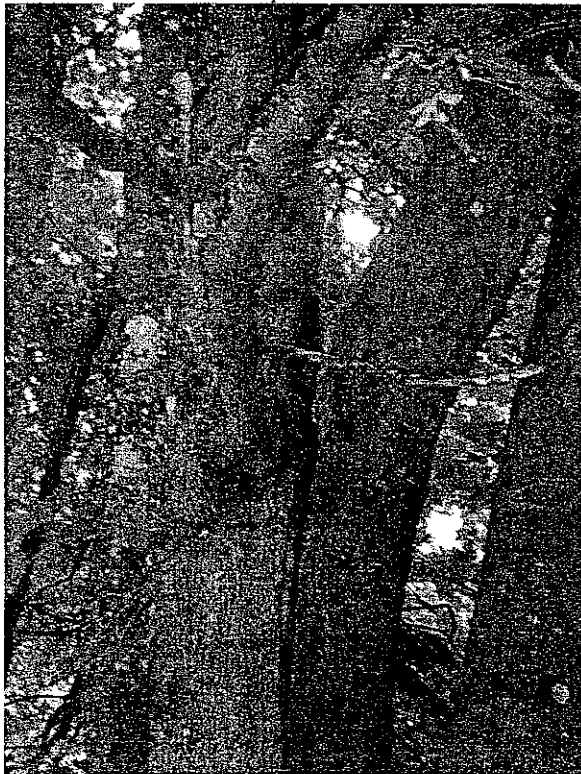
Tree #22 is made up of 2 trunks. One of these trunks forks into codominant stems, which has recently failed. See photo. The failure of this forked attachment created a split between the 2 stems, making it unsalvageable. The failed portion of the stem is hung up in the trees crown and represents a high potential for failure. This tree is considered nonviable.

Failure of Tree #22 - irreparable

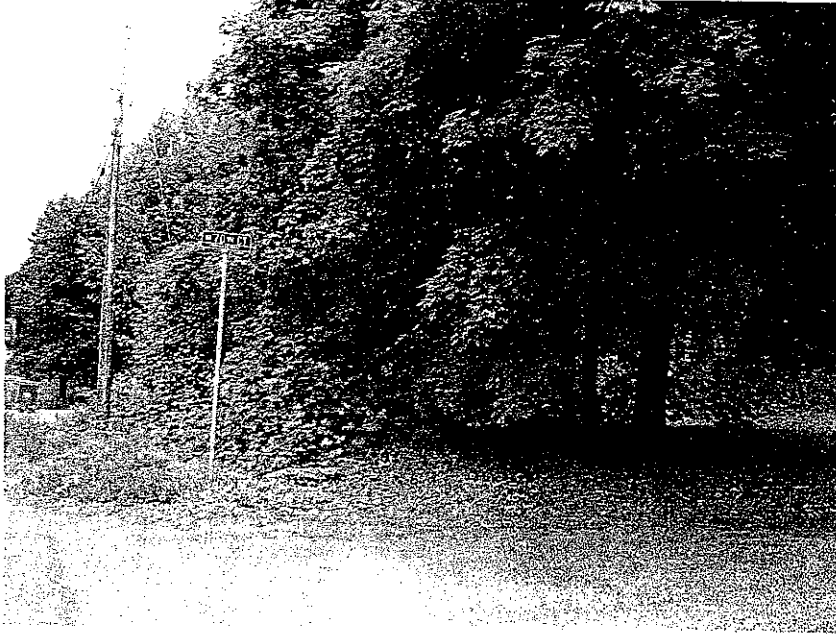
Trees #21 through #26 are comprised of a grouping of Norway maple. All of these trees contribute to one large crown. Most have developed fairly good form and typical structure. The foliage appears healthy and of good vigor. No foliar pathogens or insect infestations were observed.

The remainder of the clump is suitable for preservation. Clearance pruning will likely be required, because of the large crown spread. Tree #24 has also developed codominant stems. These appear to be fairly well attached to the main trunk. This tree should only be retained in the grouping, and not isolated or exposed.

Norway maple grouping at front of property

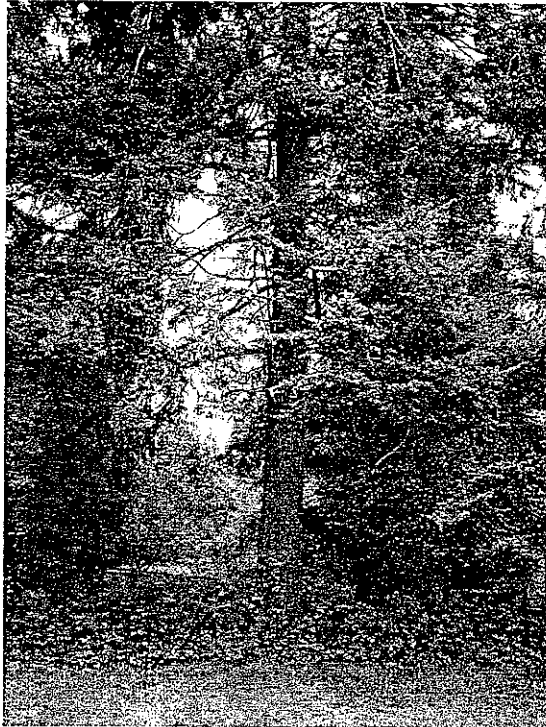
Tree #19 has developed a major crook at approximately 35' above ground. This is a mature specimen, considerably older than all of the other Douglas-fir. Failure potential is considered moderate. Swelling was observed on the lower trunk. Internal decay is suspected, likely attributable to a past injury when the tree was much younger. Continued preservation is feasible, as this tree is above the canopy and familiar with strong prevailing winds.
